# Grimes Creek Riparian Restoration Monitoring 2010 - 2012

**Chris Murphy**  
Wetland and Riparian Ecologist  
Idaho Department of Fish and Game  
Boise, Idaho

This report details results of before and after monitoring during the implementation phase (2010 - 2012) of a riparian restoration project on Grimes Creek in southwest Idaho. Approximately 4,200 m<sup>2</sup> of floodplain was restored by removing mine tailing piles left after dredge placer mining during the early to mid-1900's. Over 700 riparian trees and shrubs were planted on the site after mine tailing removal. Quantitative, reference-based effectiveness monitoring at the Grimes Creek restoration site was conducted in 2010 (pre-implementation) and in fall 2011 (post-implementation) and spring 2012. Planted species survival, woody species cover and height, herbaceous species cover and height, and ground cover features were monitored along 11 permanently marked transects. In addition, soil and floodplain characteristics were described. Results were compared to two groups of reference sites. Long-term natural recovery reference sites (> 50 years old) were located in lightly to minimally disturbed stream reaches in watersh

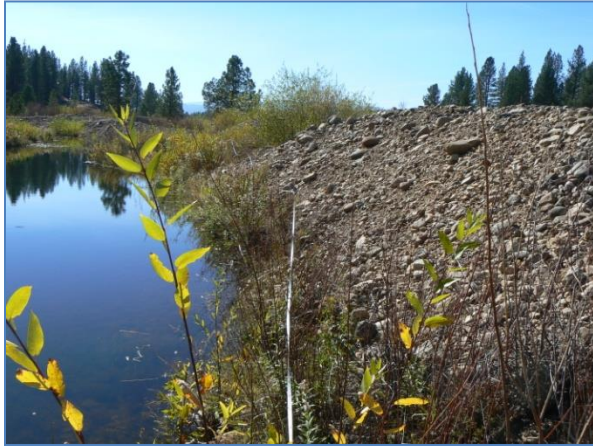
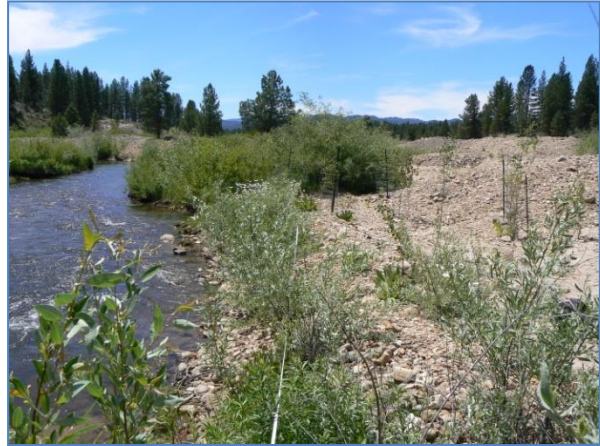
Grimes Creek riparian, before restoration and mine tailing removal, 2011 (left); Grimes Creek riparian, 1 year after restoration and tailing removal (right)

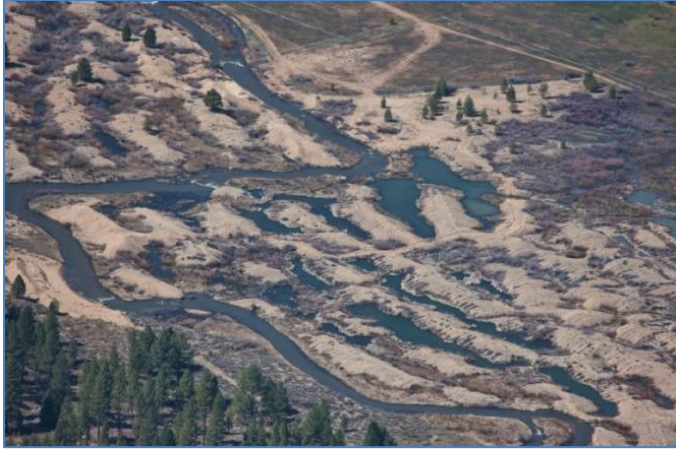
Figure 1. Low altitude aerial photo of dredge mine tailings along Grimes Creek, showing narrow bands of floodplain and discontinuous, degraded riparian habitat. Photo courtesy of Trout Unlimited.

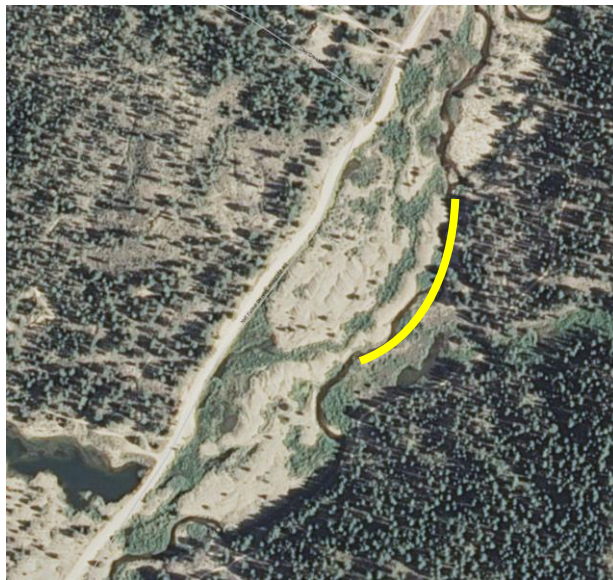
Figure 2. Restored stream reach (yellow arc), approximately 300 m long, at Grimes Creek.

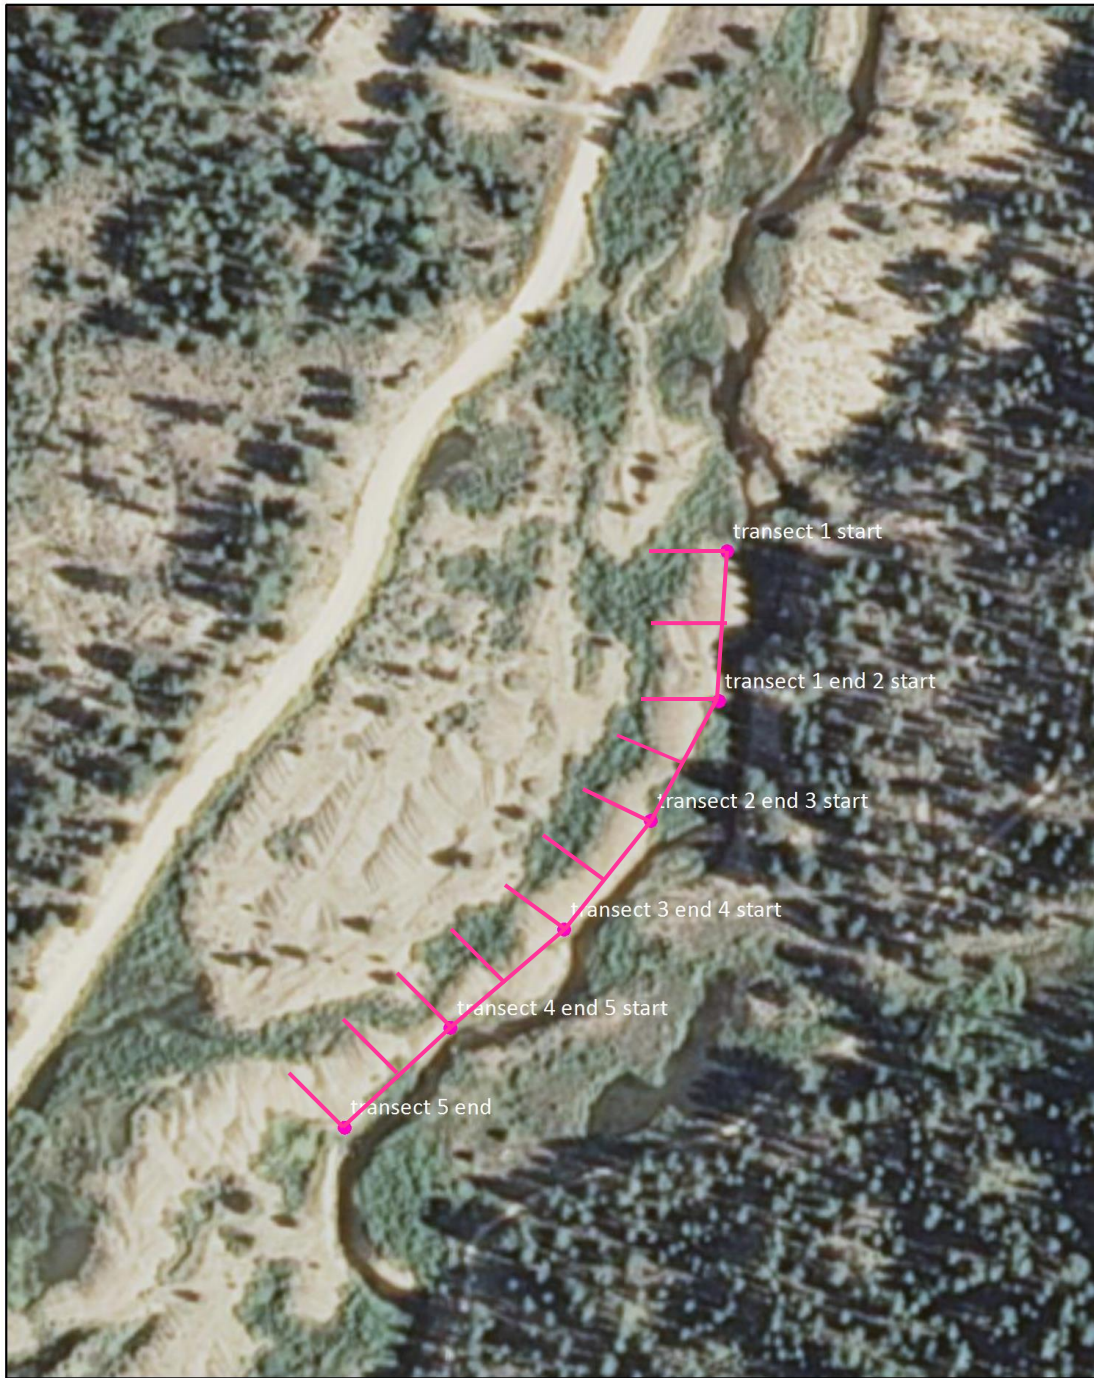
Five 50 m-long baseline transects were established parallel to the streambank through the restoration site (Winward 2000, Kershner et al. 2004, Burton et al. 2007). The baselines were contiguous end-to-end but varied in their direction due to meandering of the stream. The end-points of each transect were permanently marked with a lightweight fencepost and their locations recorded using a GPS unit. Eleven 15 m-long transects (labeled 1A, 1B, 1C, 2A, 2B, 3A, 3B, etc.) were then established perpendicular to the baselines across the restored floodplain (Harris et al. 2005). They were located at the start, mid-point (25 m point), and end of each baseline transect (Figure 4). Sampling was conducted along each 15 m transect.

Figure 4. Layout of 50 m baseline transects and perpendicular 15 m sampling transects.
